Navajo Abandoned Uranium Mine

Site Screen Report

Boyd Tisi No. 1 AUM Site

January 2011

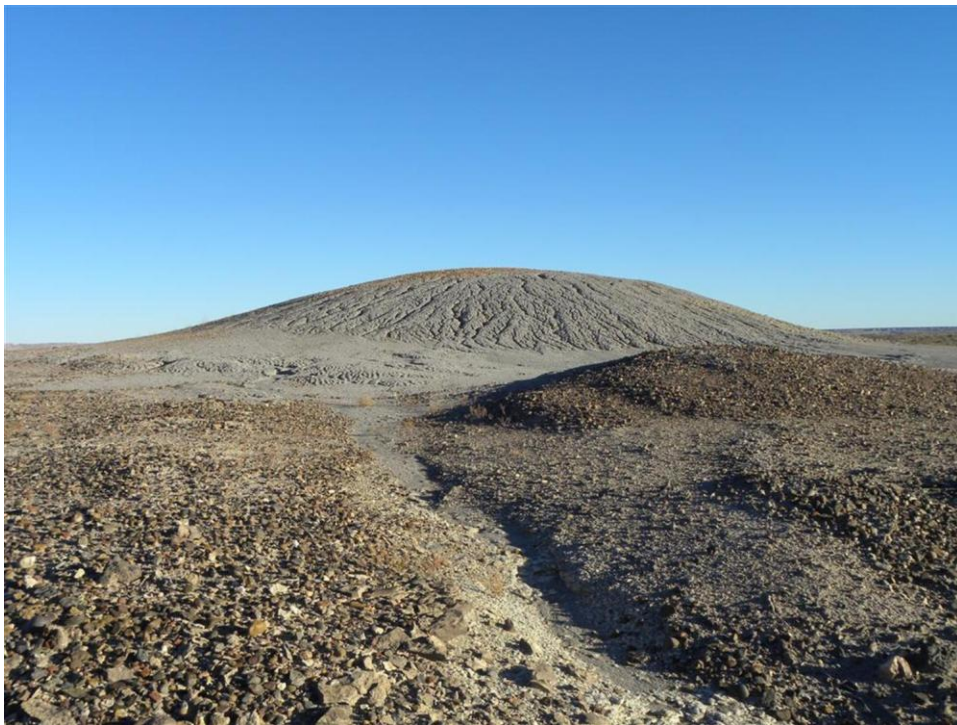
Photo 2. Boyd Tisi No. 1 mine site, reclamation cap

Reclamation cap in center of site, grey mound with red-brown soil on top, 200' x 100' x 8'

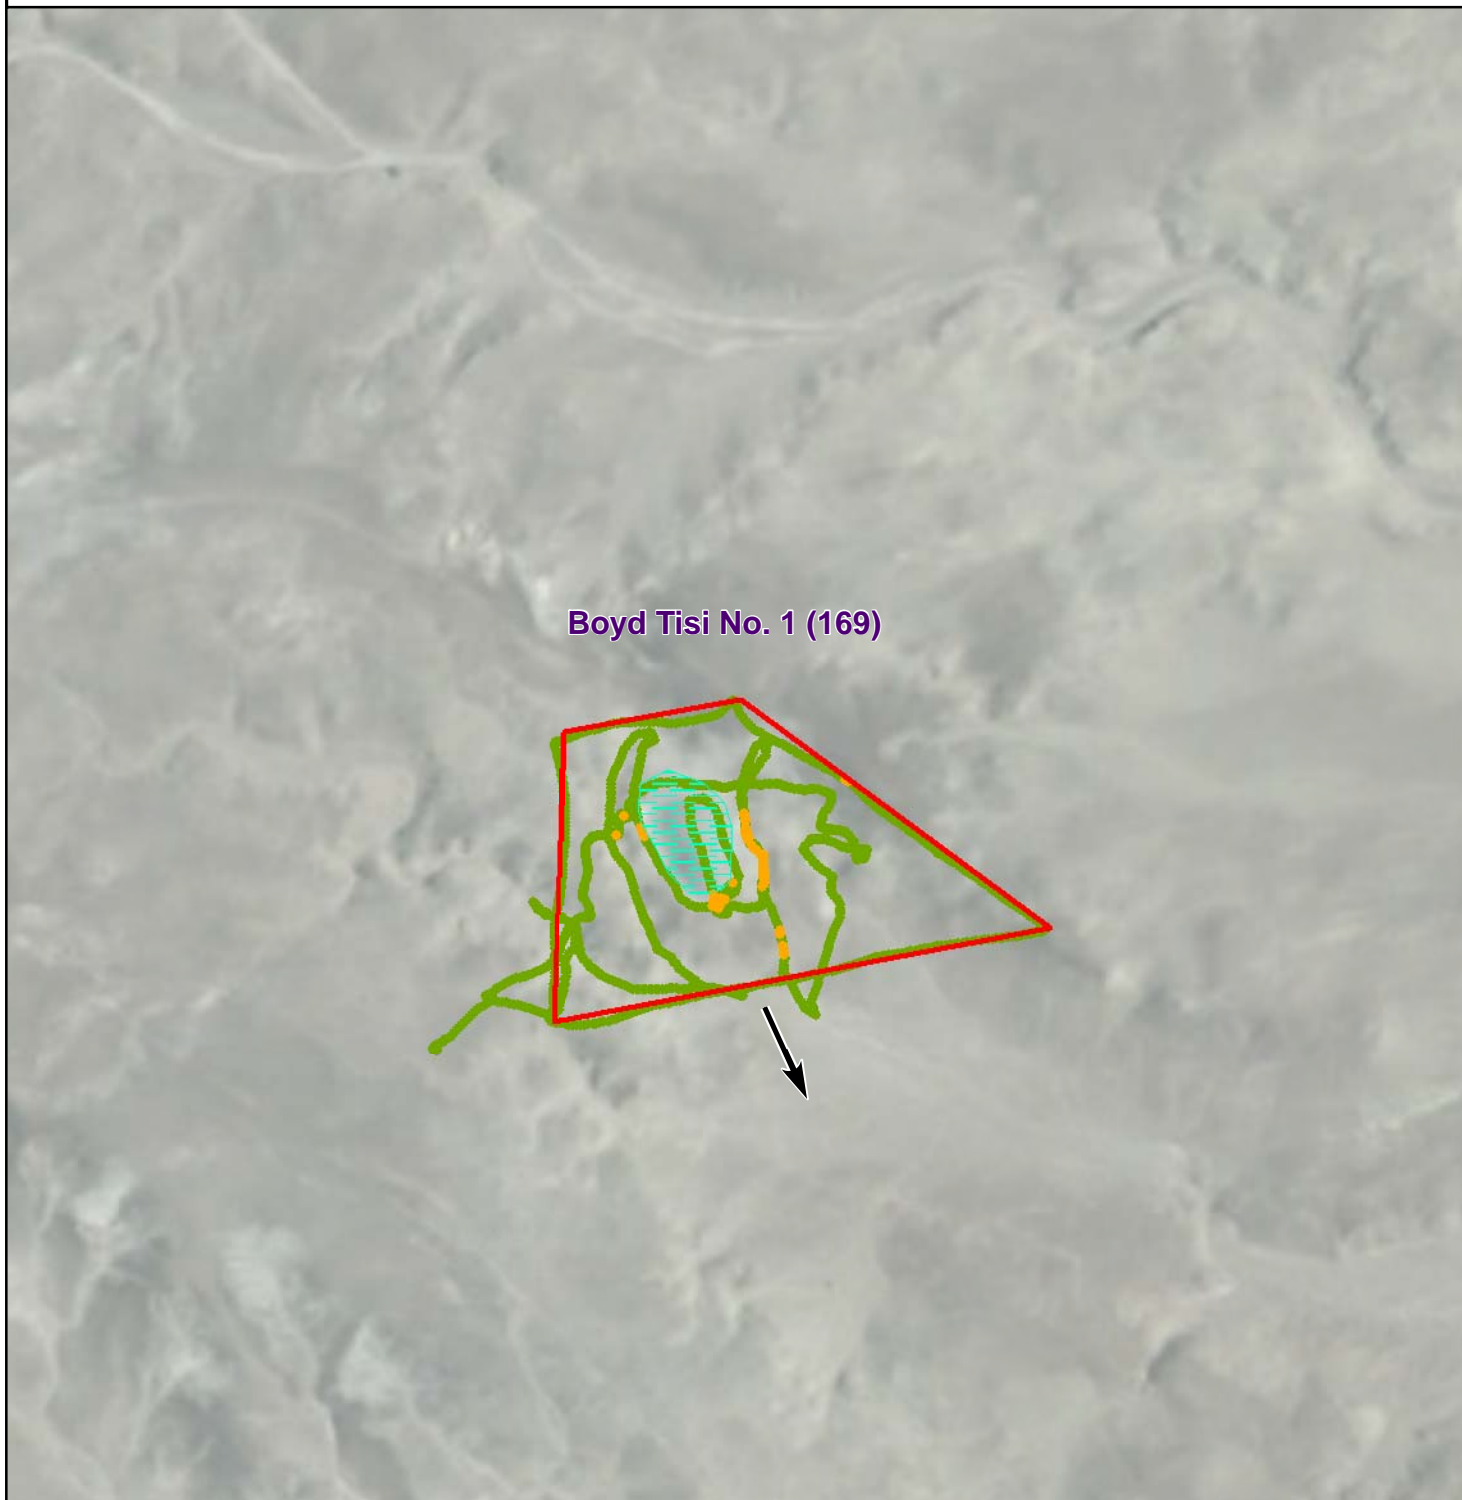
**Figure 1 - Gamma Radiation Measurements, Above Two Times Background
Boyd Tisi No. 1 (169)
Cameron Chapter, Navajo Nation**

A total of 1,614 gamma radiation measurements were collected from the mine site, ranging from 13,202 cpm to 184,494 cpm. The measurements collected throughout the site at an average level of approximately 30,000 cpm, with a few isolated hot spots with maximum levels of 185,000 cpm. The measurements are represented in Figures 1 and 2.

Gamma survey conducted 11/2010
Measured as counts per minute (cpm)

Average background 17,332 cpm

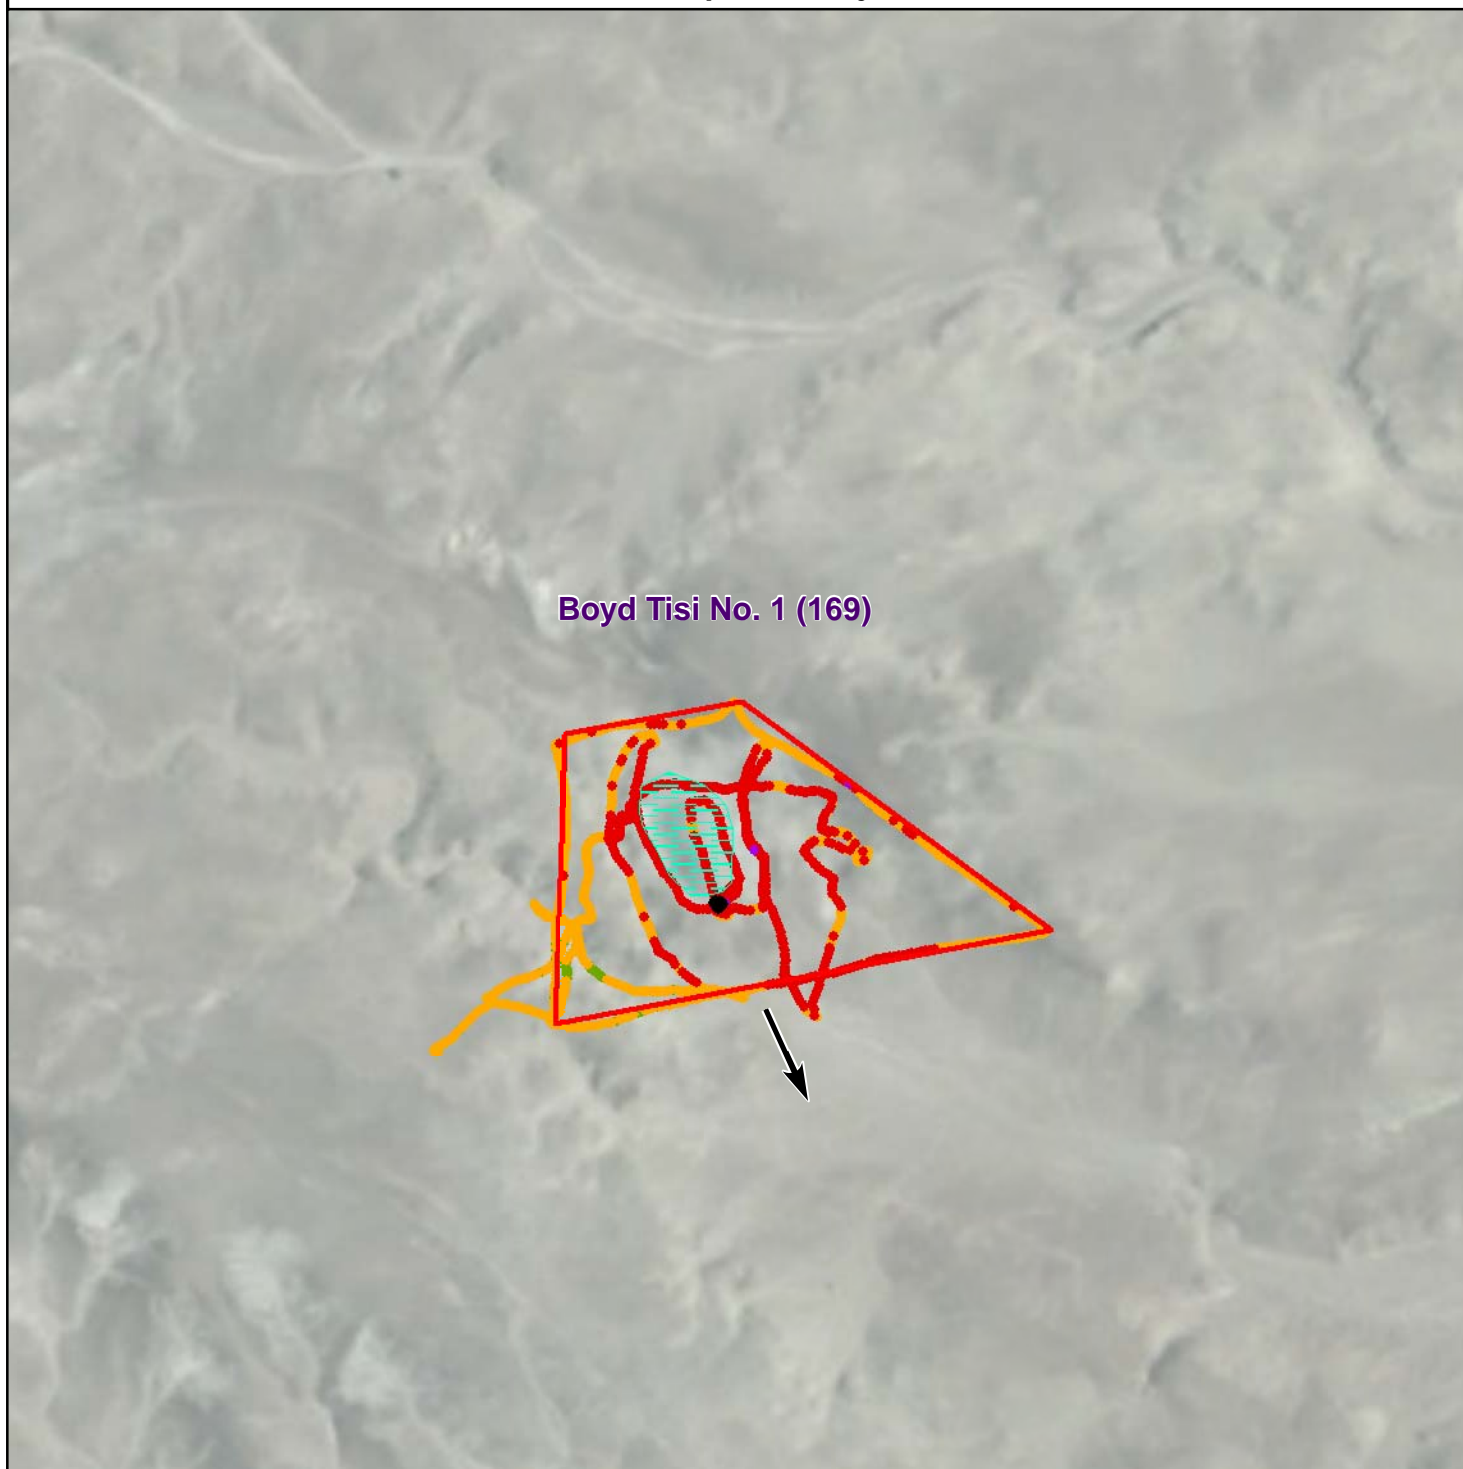
**Figure 2 - Gamma Radiation Measurements
Boyd Tisi No. 1 (169)
Cameron Chapter, Navajo Nation**

**Gamma survey conducted 11/2010
Measured as counts per minute (cpm)**

Average background 17,332 cpm
